Investigation of PCC Pavement Sections on I-29 in Pottawattamie County

**Final Report
for
MLR-06-01**

March 2007

**Iowa Department
Of Transportation**

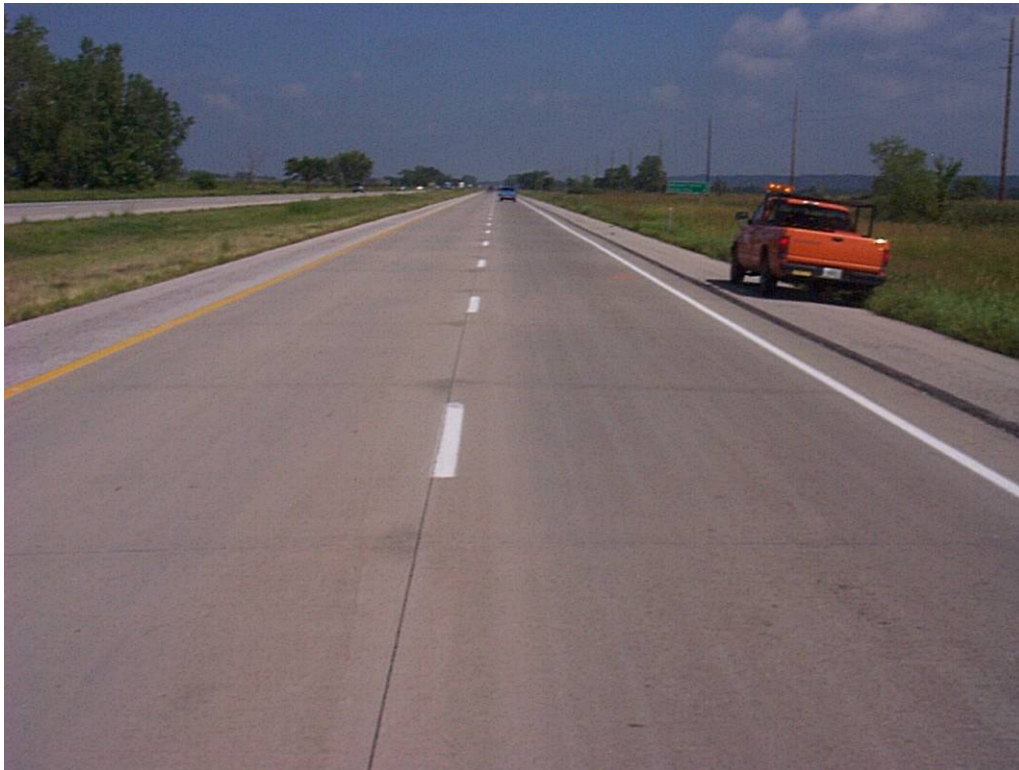
The pavement placed in 1992 began to exhibit staining at the joints in 1998. Cores were obtained in 1999 to investigate the cause of the staining. In 1999, it was noted that the staining was more prevalent in the sections containing Council Bluffs fly ash from milepost 66 north (Honey Creek interchange). The area with the worst staining occurred at approximately milepost 67.43 and minimal staining was occurring at milepost 69.40. (See Figures 2 to 5) The sections containing Port Neal fly ash did not exhibit staining at that time.

Figure 2. 1992 NB – MP 67.43 Overall condition 1999

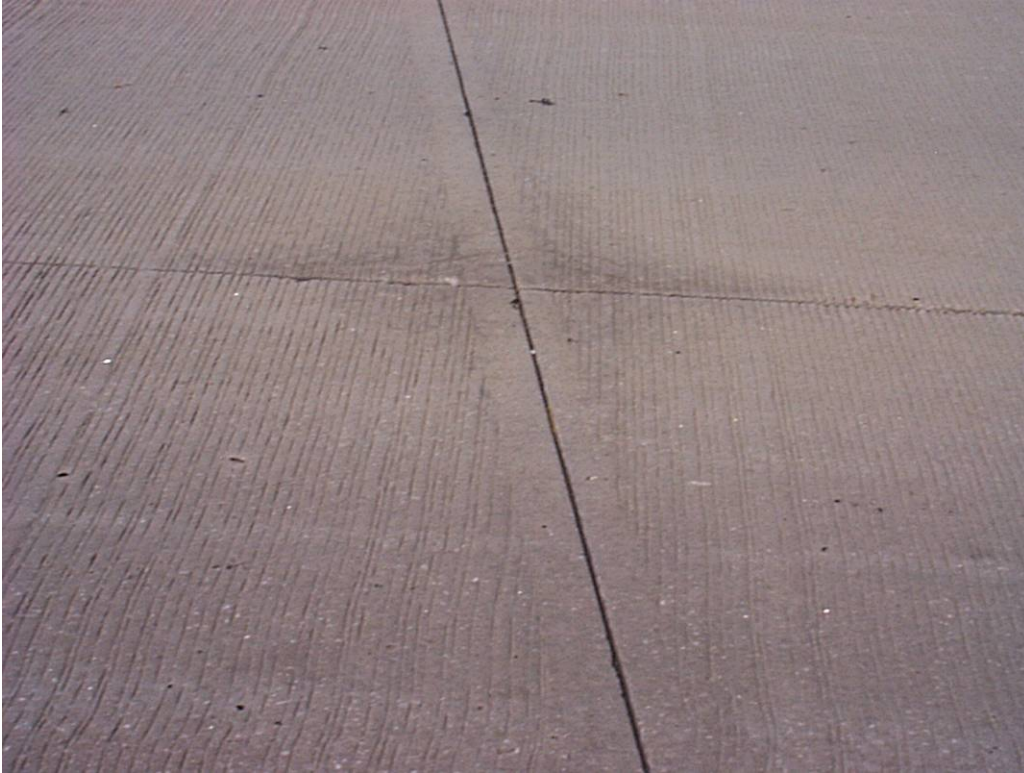
Figure 3. 1992 NB – MP 67.43 Joint close up 1999

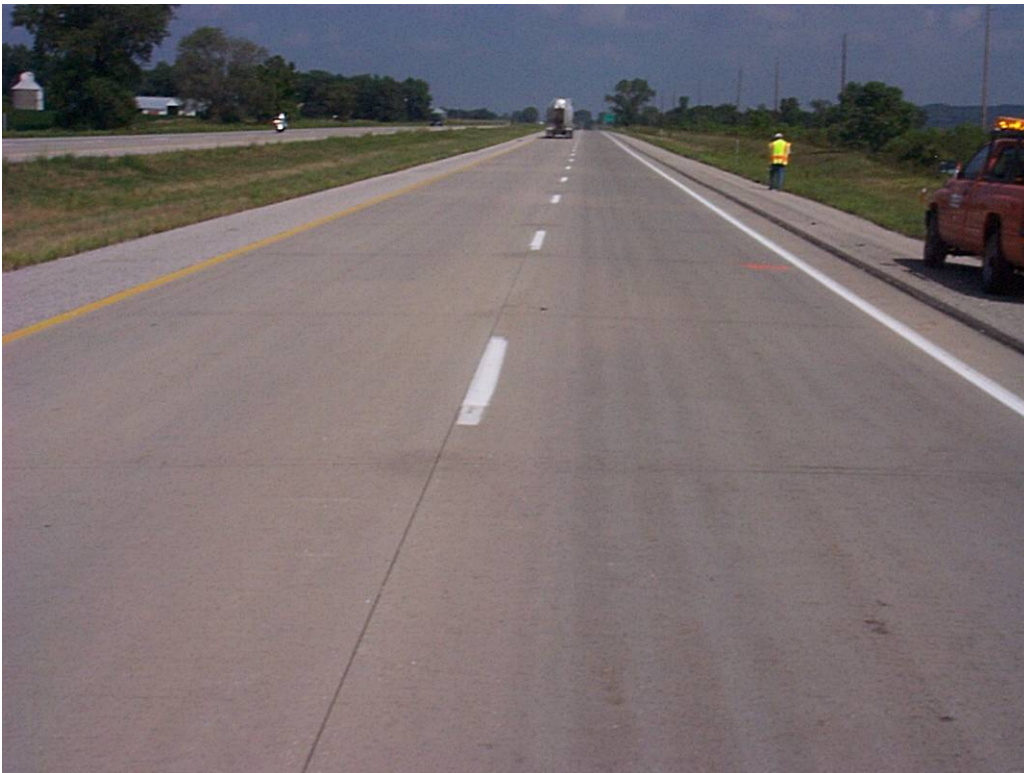
Figure 4. 1992 NB – MP 69.40 Overall condition 1999

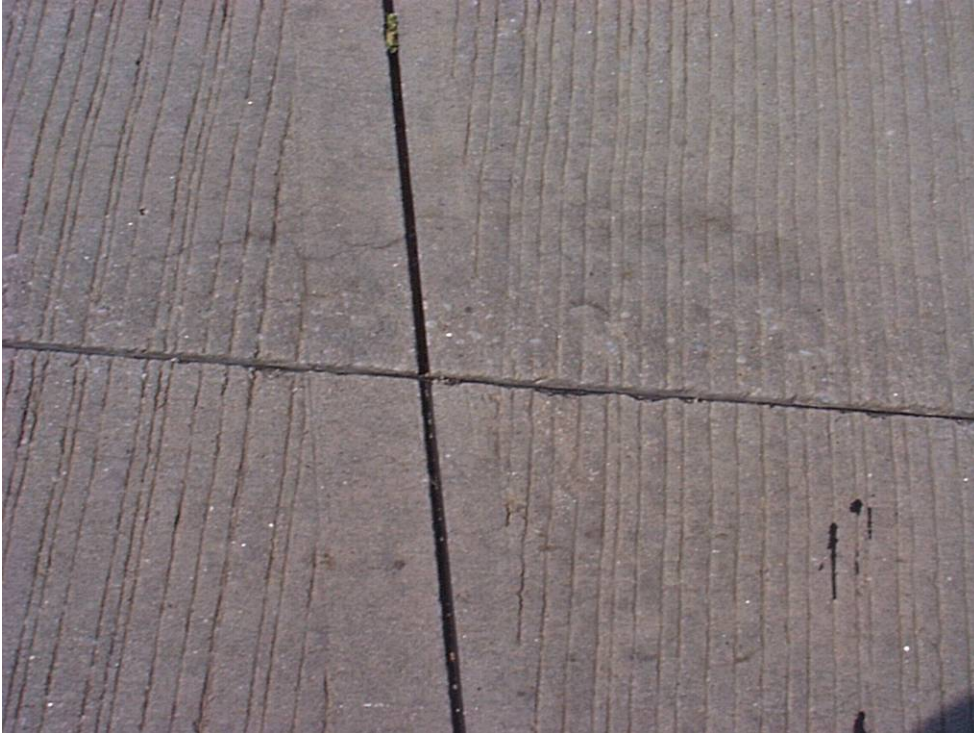
Figure 5. 1992 NB – MP 69.40 Joint close up condition 1999

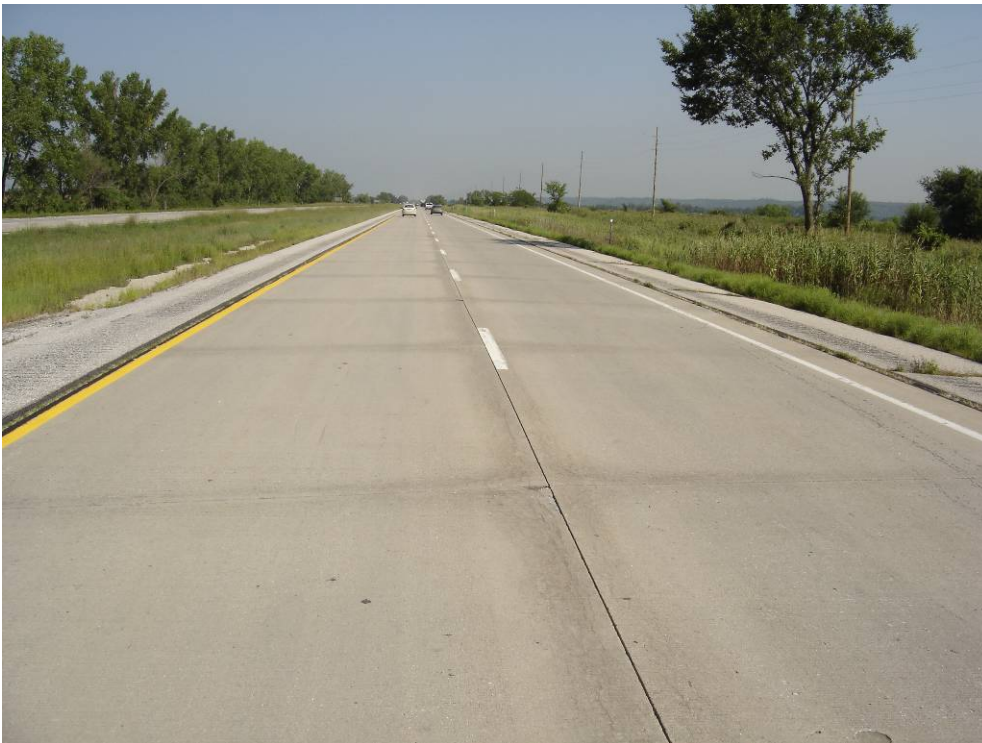
In 2006, staining at the joints had progressed in the sections containing Council Bluffs fly ash north of milepost (Honey Creek Interchange). (See Figures 6-7) In the sections containing Port Neal fly ash staining at the joints was beginning to appear. (See Figure 8)

Figure 6. 1992 NB – MP 67.1 Council Bluffs Fly Ash Section Overall condition 2006

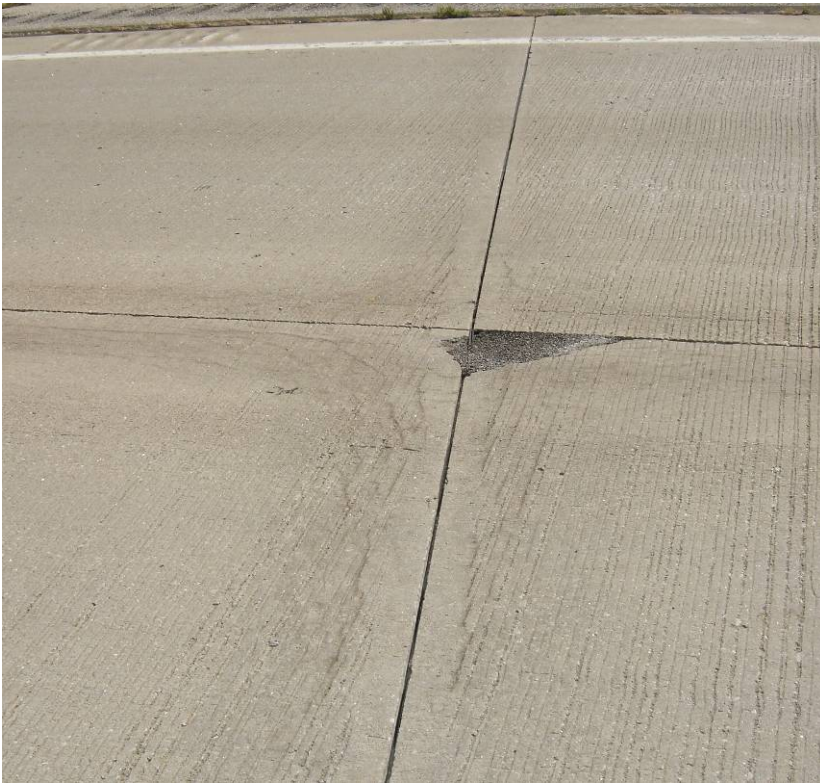
Figure 7 1992 NB – MP 67.1 Council Bluffs Fly Ash Section Joint Close-up 2006

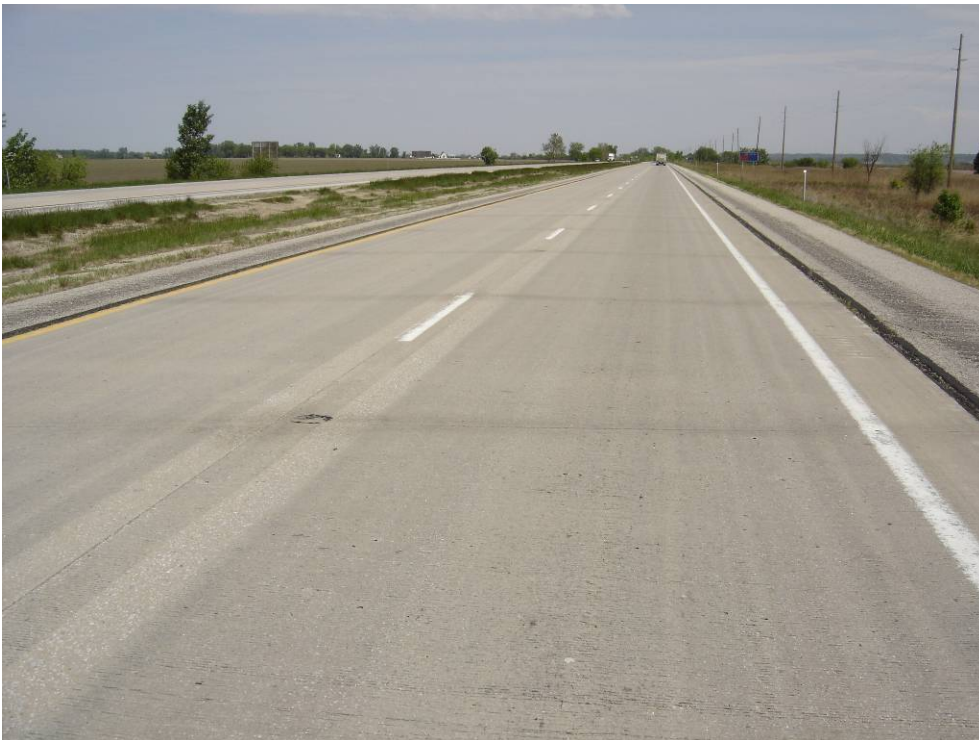
Figure 8. 1992 NB – MP 62 Port Neal Fly Ash Section Overall condition 2006

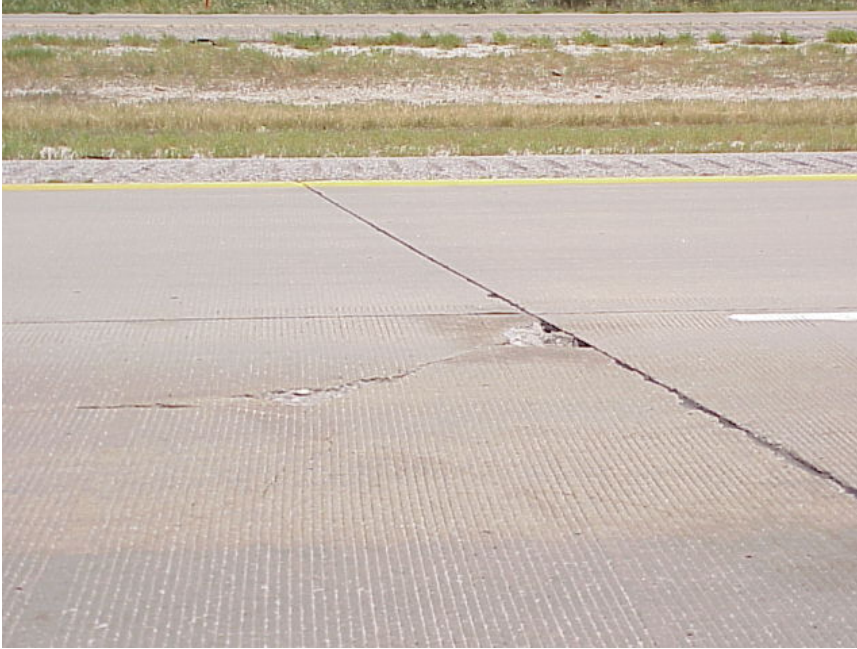
The pavement placed in 1994 began to exhibit staining at the joints in 2000. Cores were obtained in 2002 to investigate the cause of the staining. In 2002, staining was noted throughout both sections placed in 1994. (See Figures 9-10) Some spalling of the joints was also noted in some areas. In 2006, the pavement had deteriorated significantly and many of the joints have had patch repairs. (See Figures 11-14)

Figure 9. 1994 SB – MP 59.4 Joint close up condition 2002

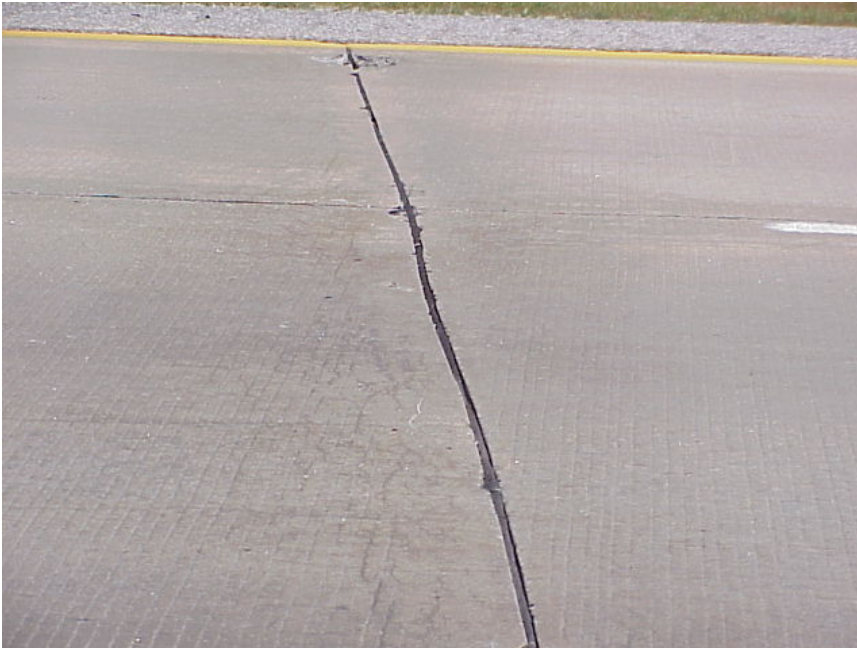
Figure 10. 1994 SB – MP 70.5 Joint close up condition 2002

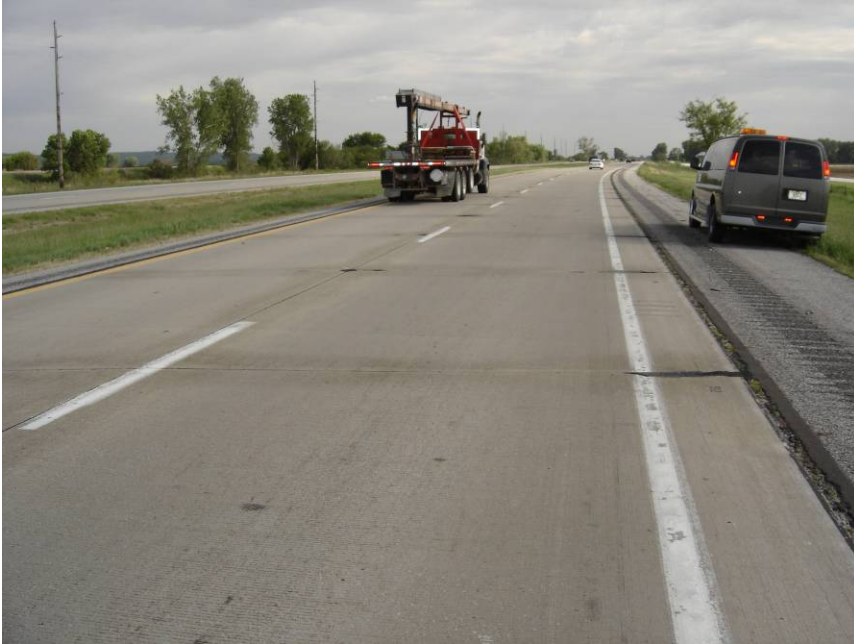
Figure 11. 1994 SB – MP 70 Overall condition 2006

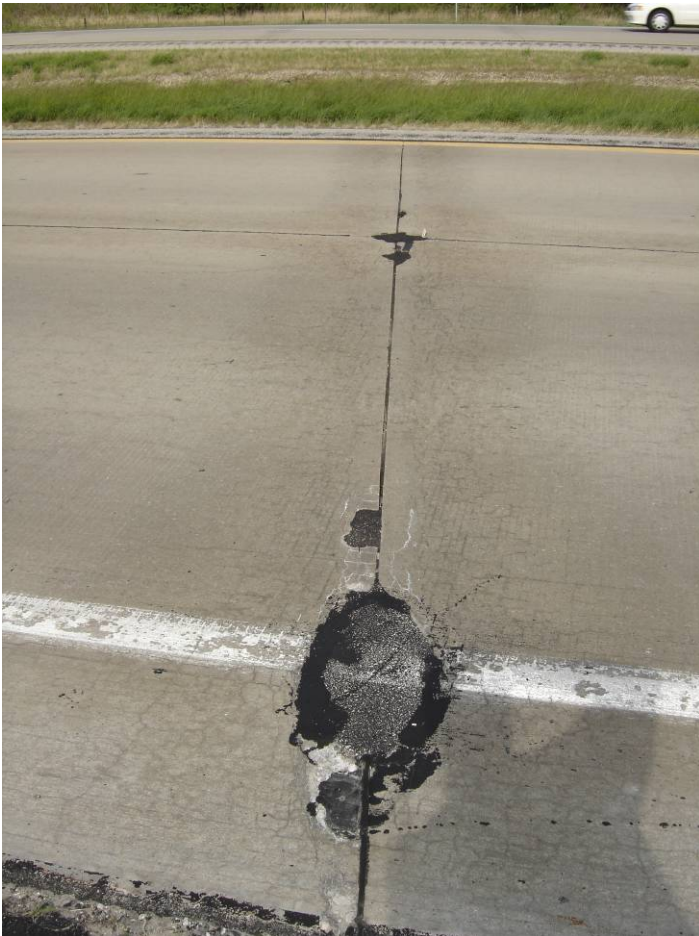
Figure 12. 1994 SB – MP 70 Joint close up condition 2006

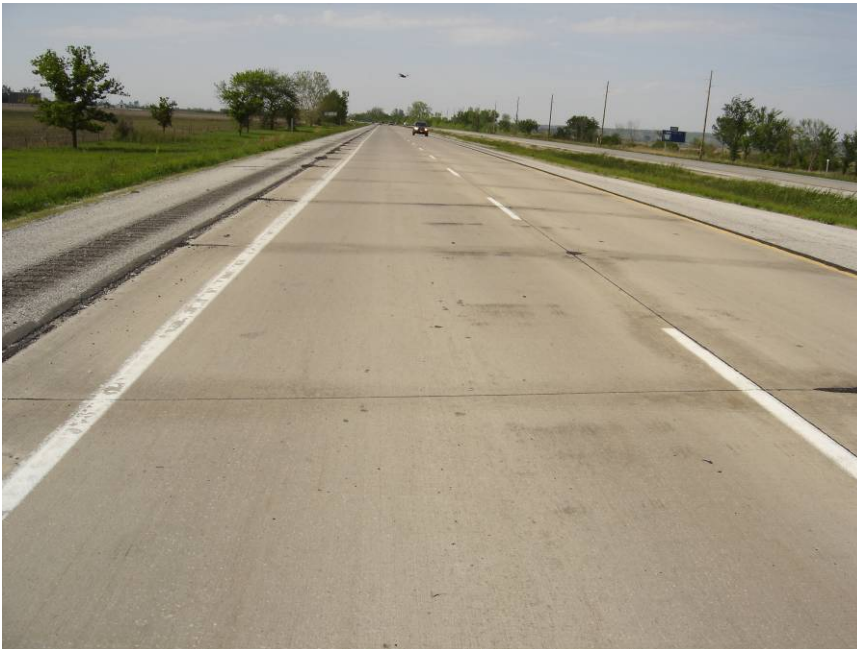
Figure 13. 1994 SB – MP 66 Overall condition 2006

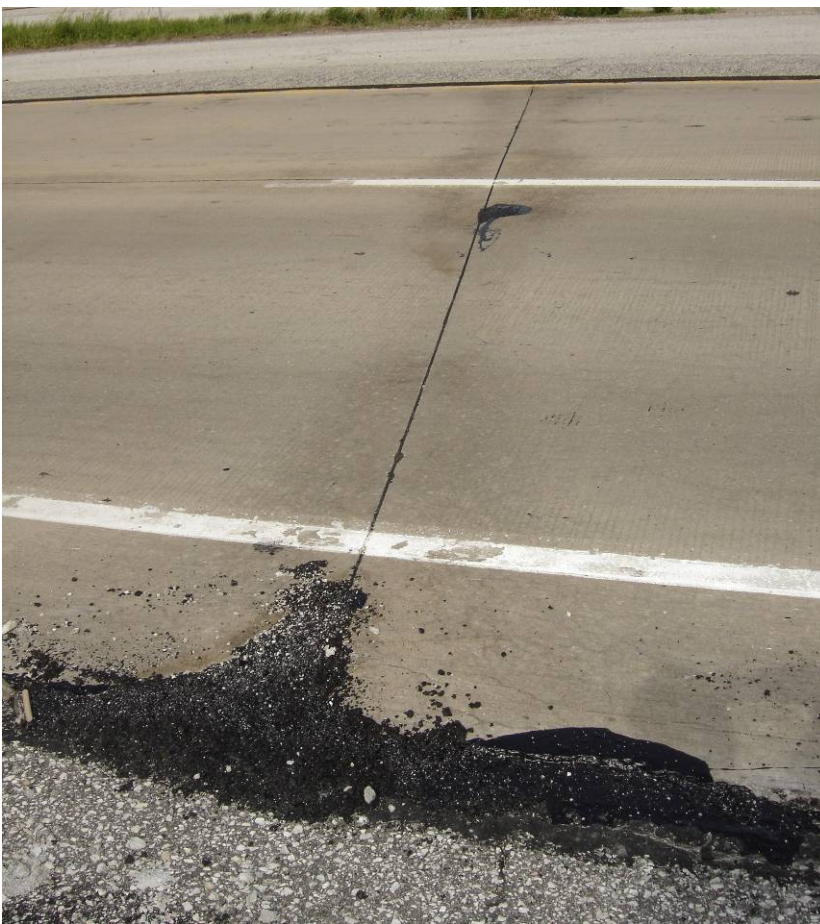
Figure 14. 1994 SB – MP 66 Joint close up condition 2006

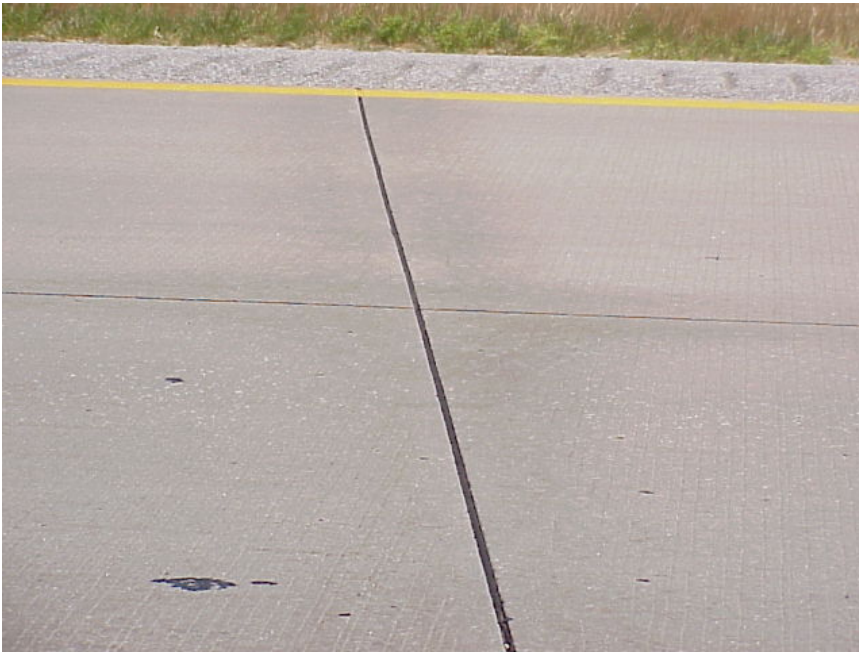
The pavement sections placed in 1995 are all in excellent condition with no staining at the joints.
(See Figures 15-17)

Figure 15. 1995 SB – MP 65 Joint close up condition 2002

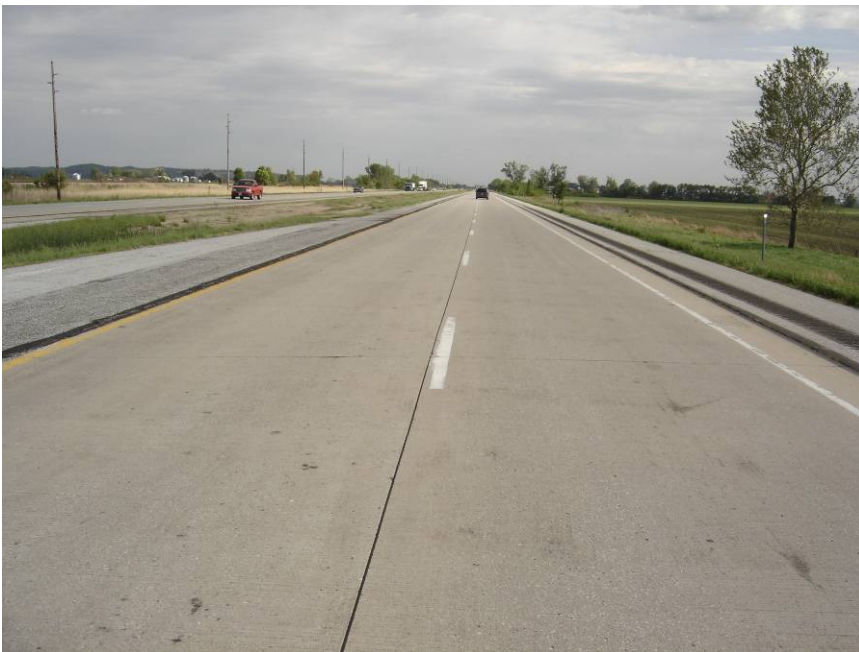
Figure 16. 1995 SB – MP 65 Overall condition 2006

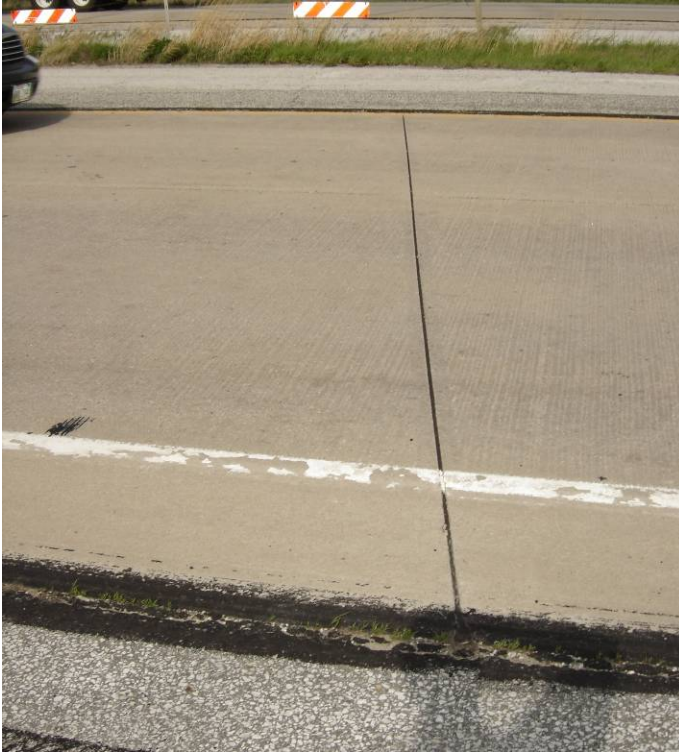
Figure 17. 1995 SB – MP 65 Joint close up condition 2006

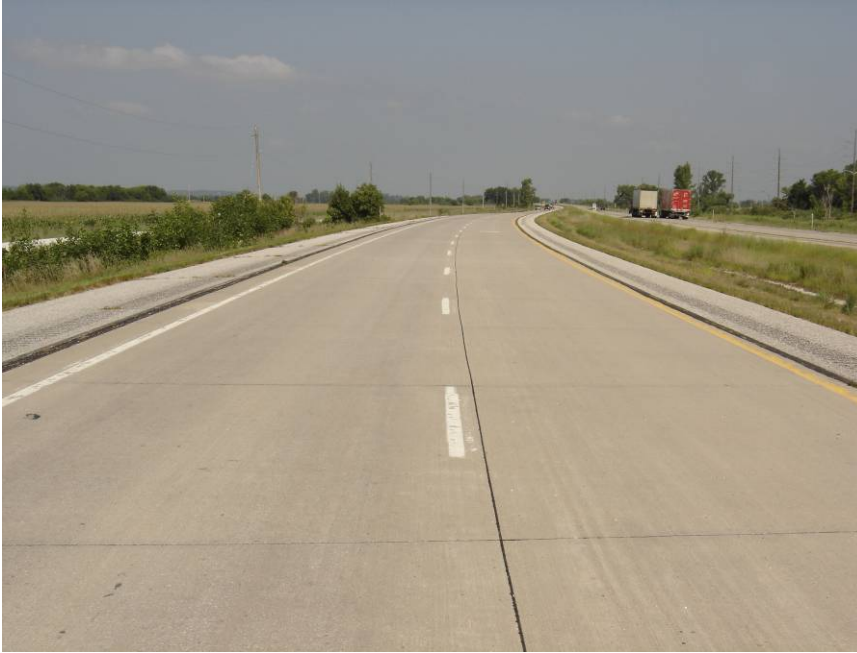
A day's run research test section was placed in 1994 using Type IP cement for the first time in Iowa. The Type IP test section is located from Station 282+08 to 231+14 southbound. Note in Figures 22 and 23, the test section is in excellent condition. This ASTM C 595 Type IP cement was produced with 17% calcined clay to eliminate expansion due to alkali silica reactivity (ASR) when Platte River gravels are used in Nebraska. Nebraska Department of Roads considers the Platte River sand-gravel aggregates to be alkali silica reactive. Use of these aggregates has exhibited a map cracking appearance.

Figure 22 – Type IP Test Section 1994 at Station 232/MP 59.5 (2006)

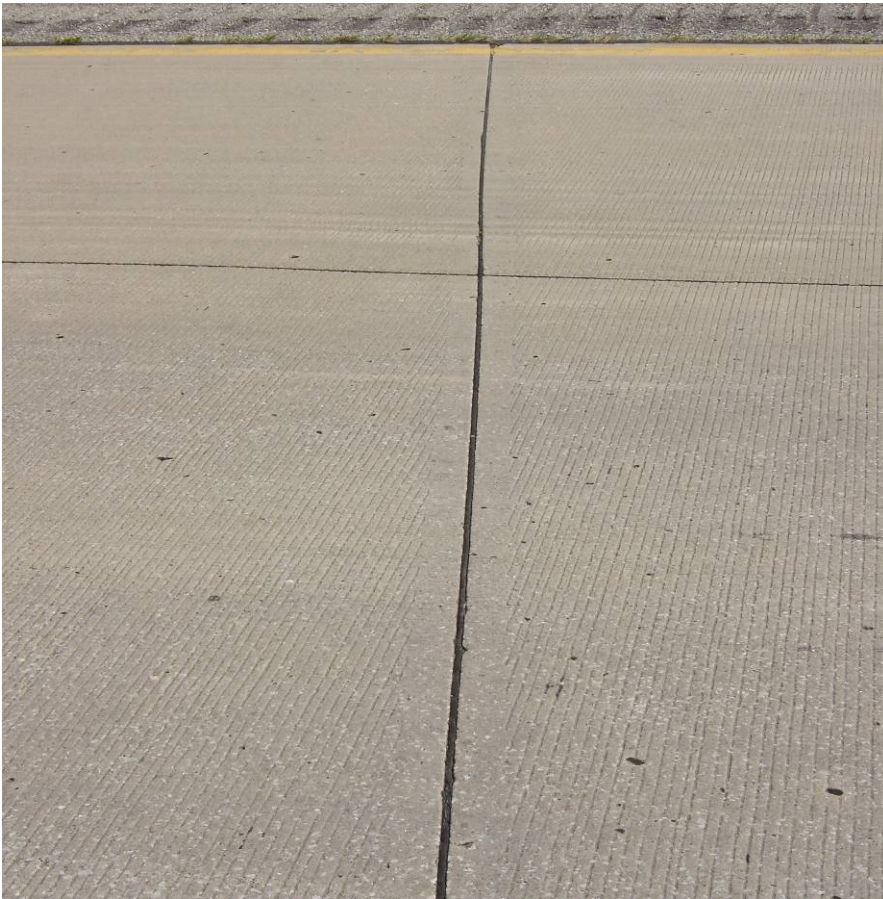
Figure 23 – Type IP Test Section 1994 Joint close up at Station 232/MP 59.5 (2006)

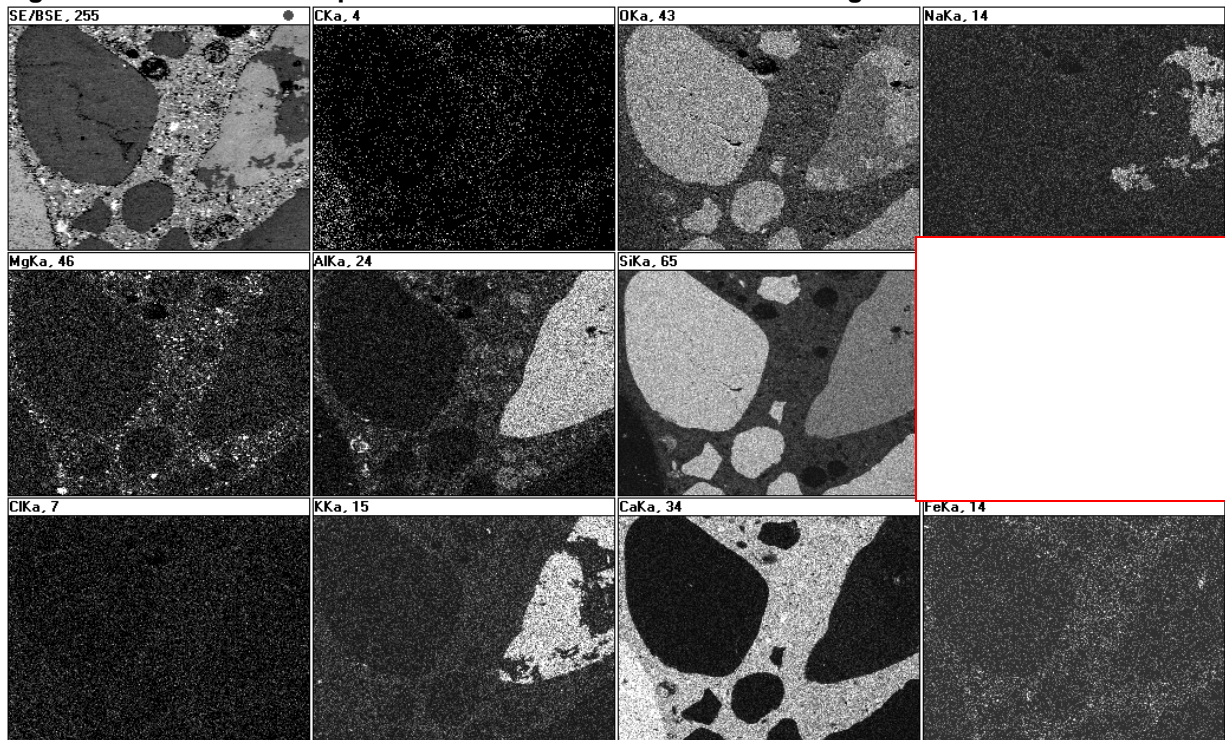
Evidence of alkali silica reactivity was not found in either location. This may be due to the use of the sand portion of the Platte river gravel and the use of limestone sweetening. However, note the white spots of sulfur (S) on the Figure 24 (highlighted in red). This is typically noted on all the pavement sections that exhibit early deterioration. Research^{2,3} has noted this to be a form of ettringite. Other research⁶ has noted the ettringite infilling to be a consequence of cracking and saturation and frost damage. Note on Figure 26, the Type IP section that is in excellent condition, the air voids are free of sulfur (S).

Figure 24. SEM X-RAY Map 100X– Core Obtained in Area Exhibiting Deterioration

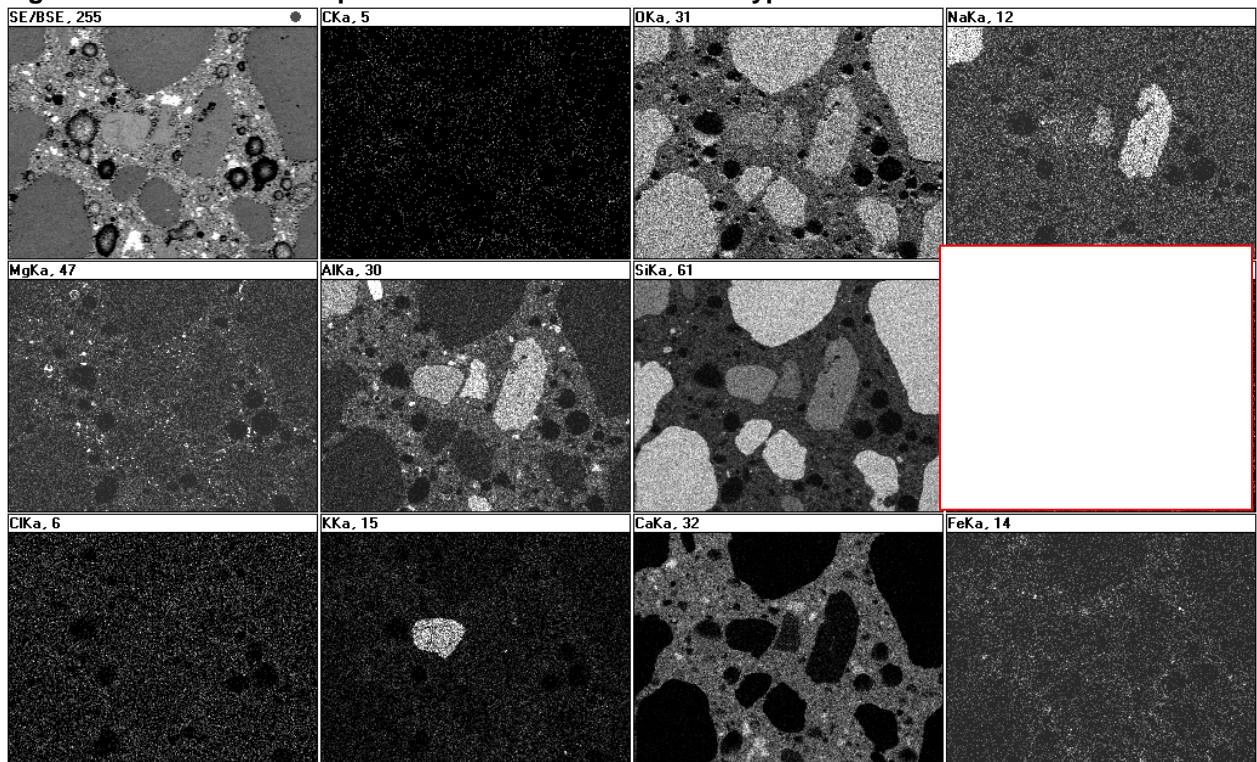
Figure 25. SEM X-RAY Map 100X– Core Obtained in Area Type IP Test Section

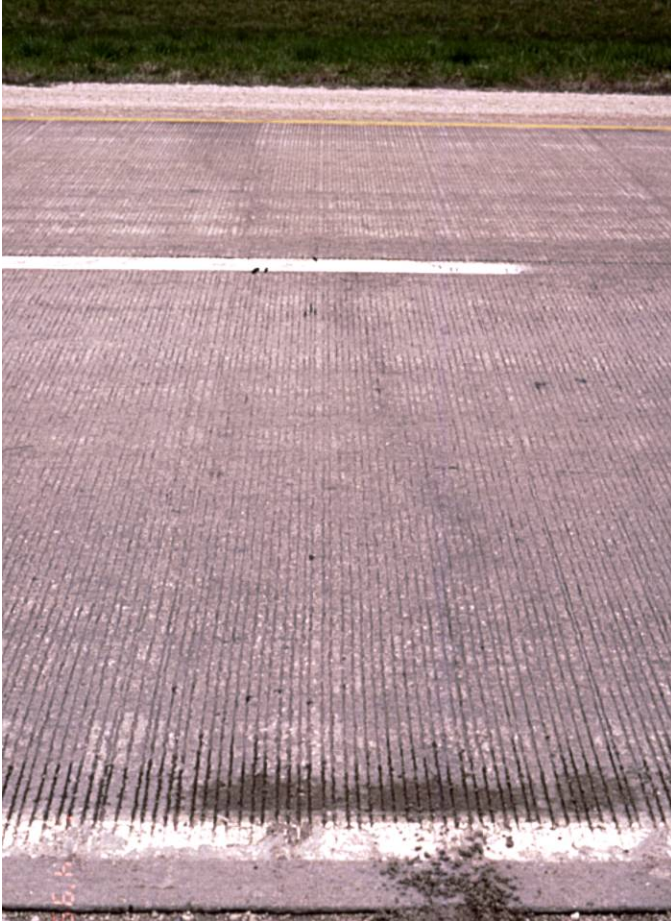
Specifications also required supplemental vibration of dowel baskets from 1984 to 1994. The US 20 project placed in 1987 was the first project in Iowa to exhibit early deterioration due to over vibration and excessive air loss in the pavement. A reinforced pavement section was placed over an old coal mine. Since the section was reinforced, there were no dowel baskets. The person performing supplementary vibration apparently continued as they went through the reinforced section. Staining and cracking was evident on the normal skew of the joint where supplemental vibration had been performed. The section eventually received an overlay. (See Figure 26) It is evident that excess vibration is a contributing factor in the deterioration.

Figure 26 – US 20 Webster county reinforced section (1991) Note staining on skew where joint would be on standard pavement section.
